Block 9, Alameda-3: Appraisal Update (Alameda reservoir)

Melbana Energy Limited (ASX: MAY) (**Melbana** or **Company**), a 30% interest holder in and Operator of Block 9 PSC onshore Cuba, is pleased to provide this operational update for the Alameda-3 appraisal well.

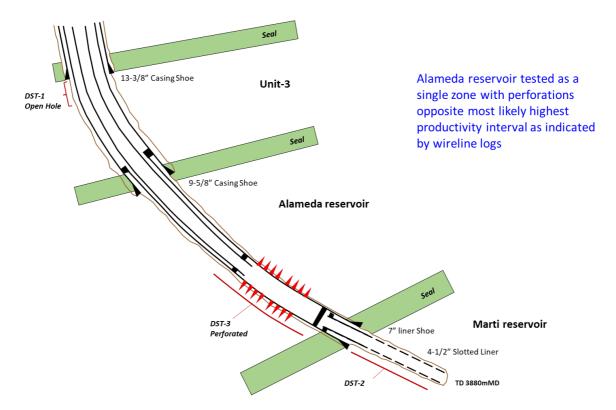
Figure 1: Positioning of the Alameda reservoir where flow testing was undertaken at depth

Flow testing of the Alameda reservoir commenced on Monday morning, Cuba time, with the successful perforation of the casing between 3272 and 3450mMD (see Figure 1).

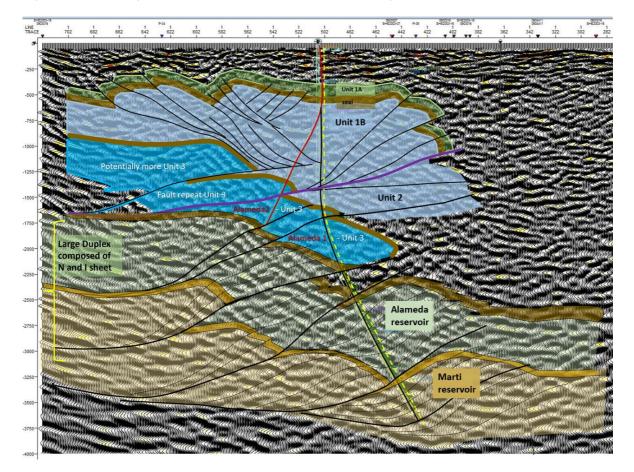
Figure 2: Depth of the Alameda reservoir relative to the Marti reservoir

The objective of the testing was to determine oil quality and flow rates for the Alameda reservoir (located above the recently tested Marti reservoir, which is separated by effective seal rocks (see Figure 2) to gain a broader understanding of that reservoir's production characteristics.

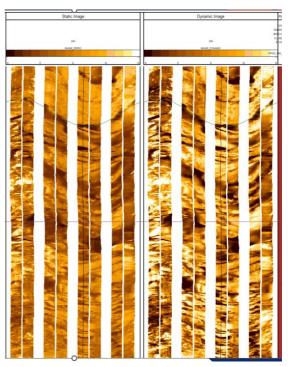
Figure 3 FMI image over Alameda reservoir showing potential good quality pay

The reservoir was tested as a single zone in the lower section interpreted to contain the highest porosity and productivity interval, as indicated by conventional log analysis and FMI (see Figure 3).

The inability of the well to flow does not fit with previous observations and expectations, given wireline and FMI over this interval indicate substantial good quality conventional (i.e. not fracture dependent) pay in addition to the highly fractured pay (see Figure 3).
