Block 9, Alameda-3: Appraisal Update

Melbana Energy Limited (ASX: MAY) (**Melbana** or **Company**), a 30% interest holder in and operator of Block 9 PSC onshore Cuba, provides this update on its appraisal well Alameda-3.

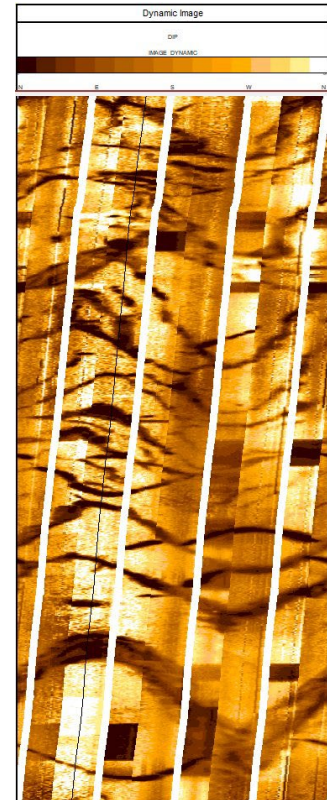
Figure 1 – FMI from Alameda-3 Marti reservoir demonstrating high degree of fracturing

The well was tested through a 4-1/2" slotted liner with a packer set at 3531mMD. Despite good indications of fracturing from wireline logs, FMI (see figure 1) and high reservoir pressures, results of the test were not as expected.
